# Numerical investigation of bridges with the aim of condition assessment in applying the Deformation Area Difference method (DAD-method) and selecting appropriate measurement techniques

**ABSTRACT:** Condition assessment of existing road bridges gains ever increasing importance today as bridges are getting older and the inflow of heavy traffic is constantly increasing. The further development of recognized techniques and the development of new methods for early and accurate detection of damage to the structure are made possible by means of innovative technological progress. In this contribution, the principles of Deformation Area Difference Method (DAD-Method) for condition assessment of bridges are presented. This method is based on the further processing of measured and computed deformation values. The application of the DAD-Method requires a precise recording of the deflection of a load-deflection test. On the basis of theoretical calculations, this method has allowed to identify as well as to localise damage to a structure. The DAD-Method is independent of a reference measurement and insensitive to global influences such as temperature fluctuations. For precise detection of d

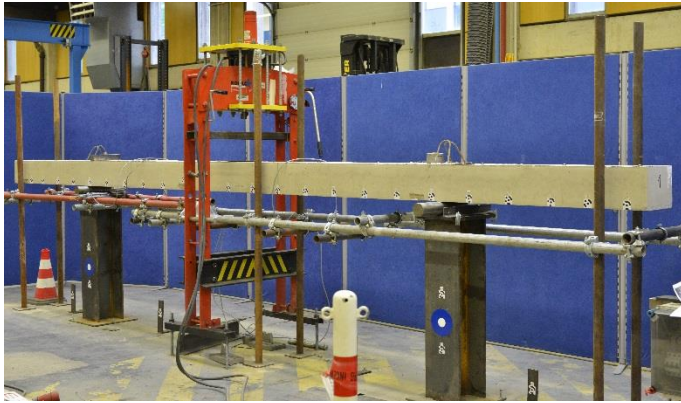
Figure 1. Test specimen: reinforced concrete beam

In this report, the results of the conducted investigations are presented. The test specimen is a reinforced concrete beam (Figure 1). In a first step, the beam was lifted on one side in order to compare the measuring techniques out their resolution to each other.

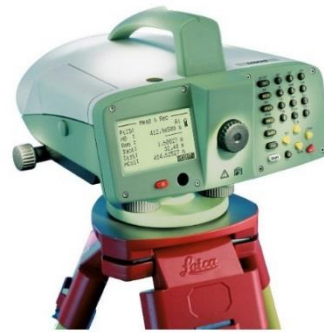
Figure 2. Digital Level Leica DNA03 (Leica Geosystems AG, 2006).

The levelling instrument employed in this study is a “Leica DNA03”, which is generally utilised for precise height measurements (Figure 2). This instrument compares on internal reference barcode with the barcode registered on the levelling rod, which is placed vertically on a point to be measured. Through a correlation process the height reading is determined. Several automatic internal readings are performed for each height measurement whereby a direct control of the verticality of the rod is given during the time of measurement. According to the instrument specification the standard deviation for the height measurement is 0.30 mm for a 1 k double levelling (Leica Geosystems AG, 2006). The significant advantages of a digital level are the high accuracy, the simple and efficient measurement, and the quick data evaluation. The measurement time for the 24 points is about 10-20 min and the evaluation takes about 30-60 min, whereby the latter could be automated to a high degree.

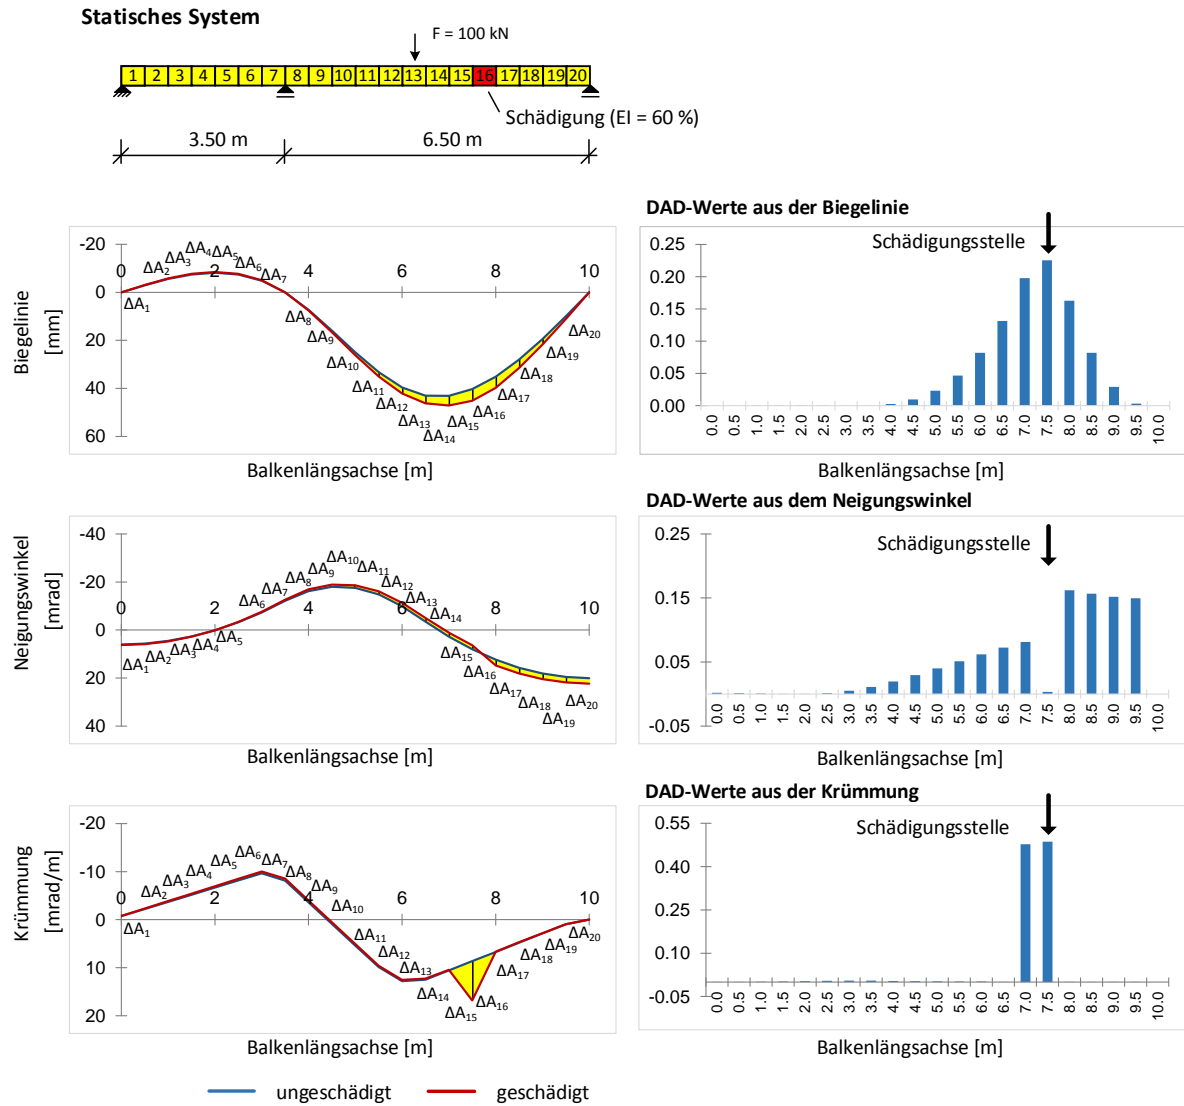
Figure 6. DAD-Method on the example of two span girder.

The objective is to develop a method which allows damage detection in structures using a non-destructive load test. The DAD-Method tries to detect and locate a discontinuity in the deformation courses of a static system by normalisation of individual areas (here until  $\Delta A_{20}$ ) over the total area. During a non-destructive load test, the structure is loaded at the serviceability limit level, whereby only small deformations are observed. The application of this method provides the possibility to detect and show hidden discontinuities in deflections. The DAD-Method is demonstrated on the example of a two-span beam (Figure 6). The non-uniform two-span beam with a total length of 10 m was modelled in a FE-Program with a mesh length of 50 cm. The mesh length provides the deformation values at spacing of 50 cm in the longitudinal direction of the structure. A difference can be observed between the damaged and undamaged system. In this example, a local damage is generated at the spot of element Nr. 16  $x=7.75$  m (Figure 6) by reducing the stiffness of the element to 60 %. However, the degree of damage is not detectable using the DAD-Method. Due to the calculation of deflections, and curvatures, the bending line is given as starting point. Initially, the first derivative of the bending line at the location of damage is determined. However, in most cases, the establishment of the second derivative of the bending line, the curvature, is needed to give a clear statement about the location of the damage. According to Figure 6, under consideration of the DAD-values, the damage to the two-span beam is detected at the position between  $x=7.0$  and  $8.0$  m. The precision of the localisation (here  $\pm 50$  cm) depends on the mesh density of the numerical computation. For in-situ measurements, this corresponds to the density of the measuring points on the girder.

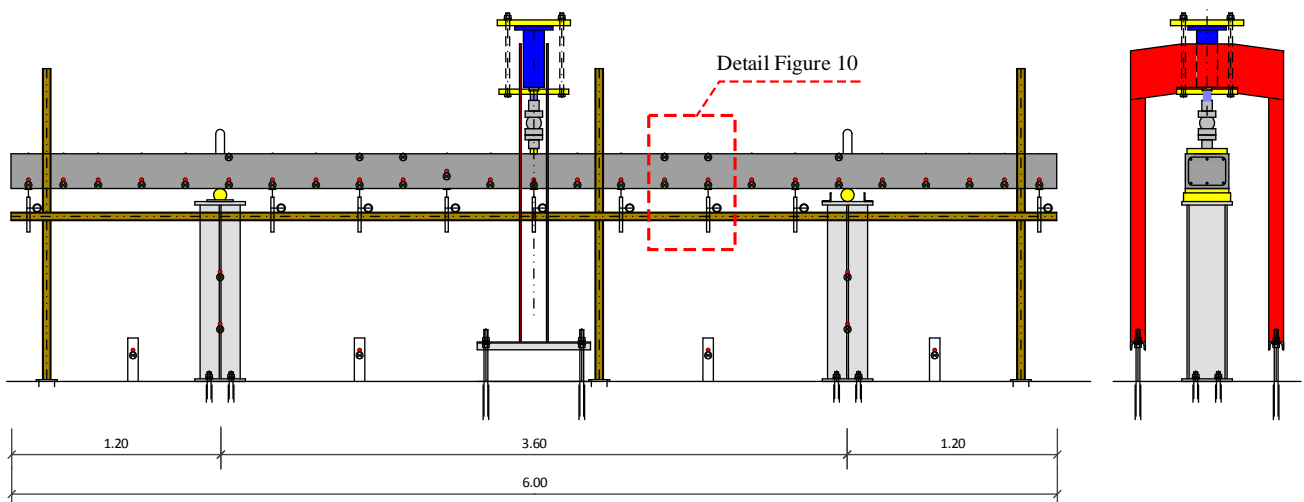
Figure 7. Test specimen: side view (left), cross section (right).

The test beam (Figure 7) prepared was firstly lifted by 2.50 cm in order to perform the first comparison of the applied measurement technologies. The center of

rotation, respectively, the neutral axis of the girder is the left support at  $x=1.20$  m. On the girder were unilaterally fixed 31 targets for the close range photogrammetry (Figure 13), 25 targets for the total station and above the girder 24 benchmarks for the levelling (Figure 9). Additionally, different benchmarks are positioned at base level as well as at the support.

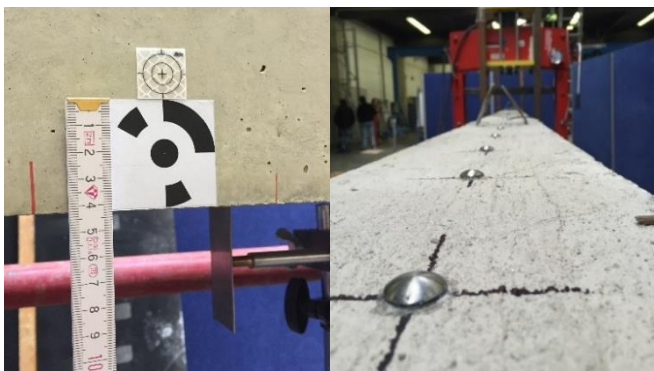
Figure 9. Targets for close range photogrammetry and total station (left figure), benchmarks for levelling (right Figure).

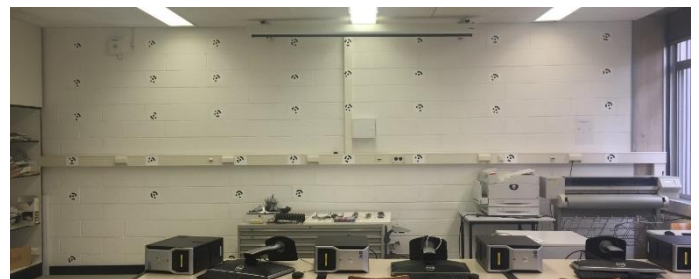
Figure 10. Calibration wall, University of Luxembourg.

The results realised by close-range photogrammetry are very dependent from the boundary conditions like the employed camera, the camera calibration, the distance to the object, the lighting conditions and the quality of the recording. For the calibration, in a separate room, targets were positioned on a 3.00 x 7.00 m white wall. There targets were measured using the total station (Figure 10).

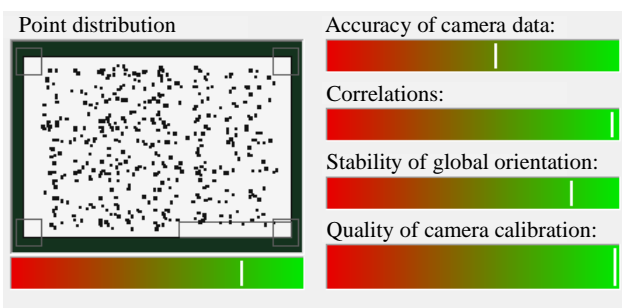
Figure 12. Point distribution and quality of the camera calibration

In the next test, the object is additionally captured from a camera position which is turned by 180 degrees to ensure that each aperture range encloses the left and right edge points of the beam and that at least 4 targets are overlapping in both pictures (manufacturer requirements). The quality of the calibration can be different depending on the distribution of the points (Figure 12) over the imaging sensor.

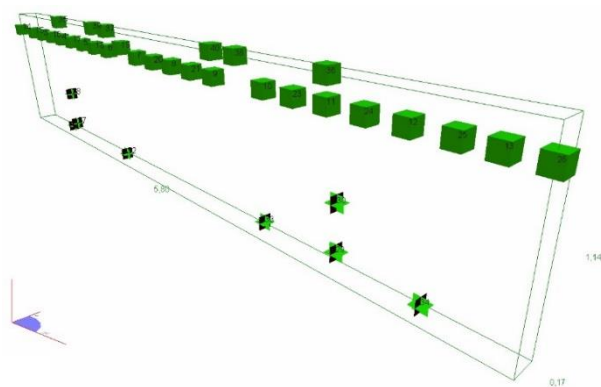
Figure 13. top (cubes): the targets (measuring points) on the test specimen, bottom: reference points (points for orientation).

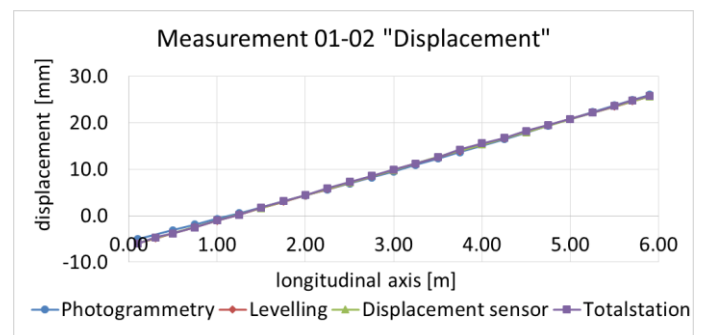
Figure 15. Measured displacements for Measurement 01 and Measurement 02.

Altogether, three measurements were carried out over three days. Measurement 01: Reference positions and initial state, Measurement 02: one side lifted state, Measurement 03: the lowered state, corresponding to the initial state. The measuring points are distributed in the longitudinal direction from  $x=0.10$  m to  $x=5.90$  m. Figure 15 shows the displacements between the initial state and the lifted state of the beam. At this scale, the results of the measurement techniques show good agreement. Figure 16 represents the deviations between the different measurement techniques with respect for the levelling results.

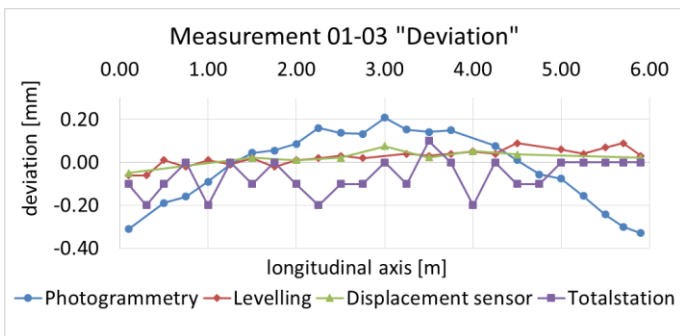
Figure 17. Deviation between Measurement 01 und Measurement 03

Figure 17 shows the difference between Measurement 01 and Measurement 03 i.e. the difference between the initial state and the lowered state. It can clearly be seen that the initial state is not fully restored after lowering of the beam. While the values from levelling and the displacement sensors almost coincide, a scattering of the values from the total station and photogrammetry can be observed. The measurement with the total station show a wider distribution of the values. However, the scattering behaves regularly over the 25 measurement points. This can be explained by the standard deviation as each measurement includes a measurement error. Figure 15 and Figure 16 show the more systematic behavior for the photogrammetric results. This might be explained due to the fact that the reference points are located below the beam. Therefore for further measurements, it is recommended to position additional reference points above the beam (for example on the wall of the experiment hall) to enclose the points of interest within the reference points. In Figure 17 the blue line corresponding to the values from photogrammetry shows an arch-like course instead of a uniform distribution (similar to the line from the total station). This indicates a systematic bias in the current results which is attributed again for the camera calibration or the location of the reference points with respect to the test beam. Hence, the full potential of the photogrammetric technique has not been reached.

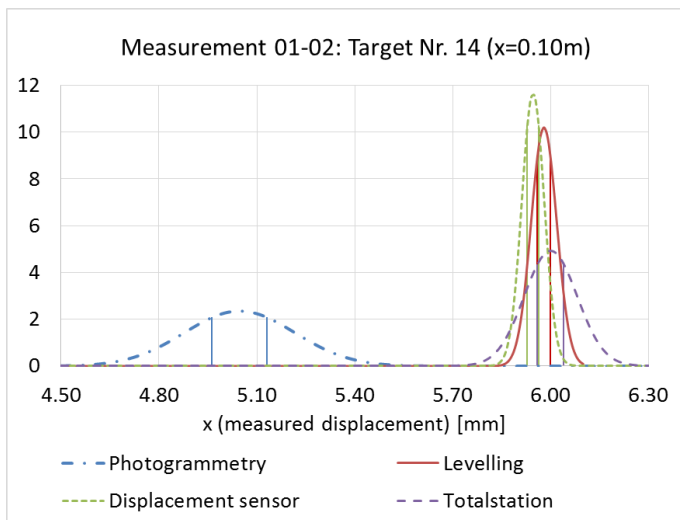
Figure 18. Standard deviation at measuring point  $x=0,10$  m

By comparison of the standard deviations, a final statement on the quality of the measurements can be reached. The individual techniques are listed in Table 2 according to their order of precision. At the measuring point  $x=2.00$  m the results of photogrammetry show the highest coherence, whereas at  $x=0.10$  m the lowest consistency can be observed. From the comparison of the measurement techniques, it can be concluded that the displacement sensors with a standard deviation of 0.034 mm represent the measurement techniques with the most precise results (Table 2). For better overview, these values are illustrated according to the Gaussian distribution (Figure 18 and Figure 19). The horizontal axis represents the measured displacement for the corresponding point, while the width of the curve is defined by the standard deviation.

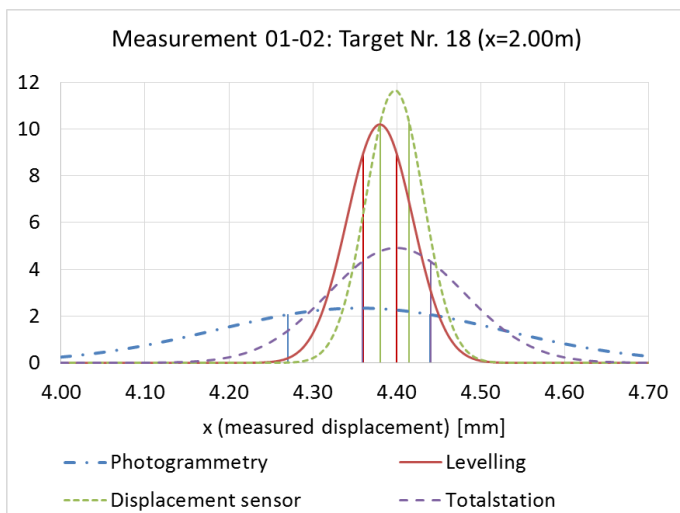
Figure 19. Standard deviation at measuring point  $x=2,00$  m
